MAKROSAFE Holdings (Pty) Ltd

SAFETY ALERT!

Fire Extinguisher Failure

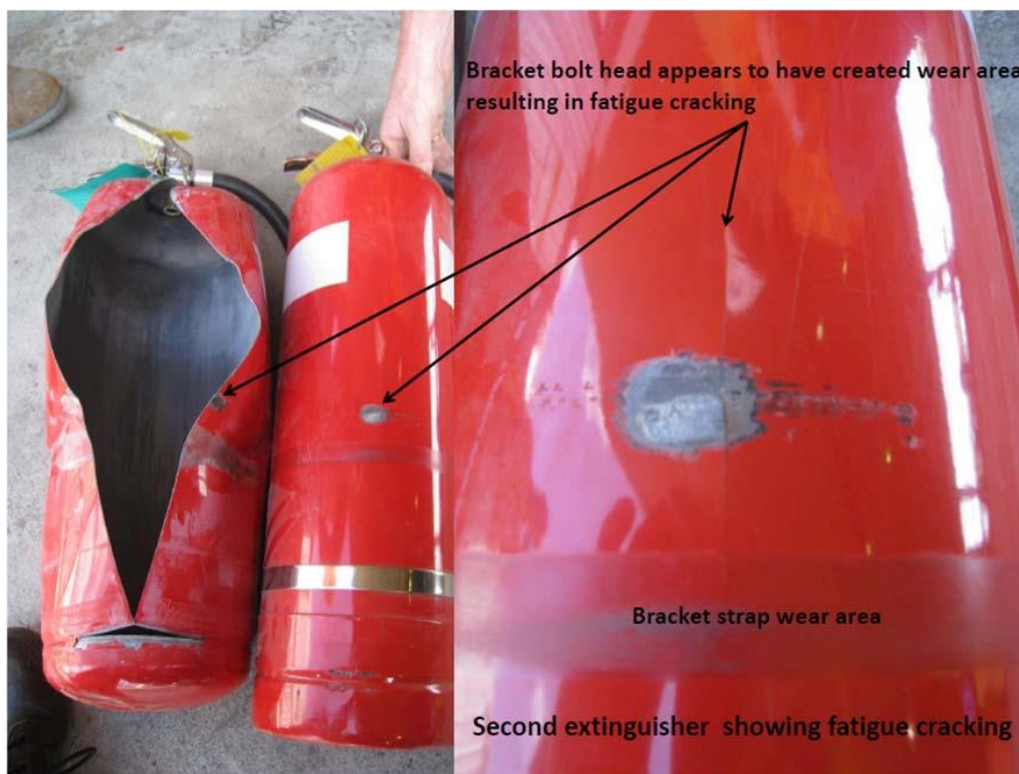
A facility experienced a fire extinguisher cylinder failure. This particular fire extinguisher had been mounted on mobile equipment.

The investigation identified areas of abnormal wear and fatigue on the fire extinguishers. This may have been caused by brackets / hardware that were used to mount the extinguisher to the mobile equipment.

- ✓ Fire extinguishers on vehicles, forklifts, and anything outdoors or mobile are subject to more wear and fatigue than fire extinguishers in buildings. For this reason, vehicle-mounted extinguishers need to be inspected for rust or damage on a regular basis.
- ✓ Check for proper mounting of fire extinguishers where bolts or hinges can possibly rub on the extinguisher, creating a weak point.
- ✓ Check also for corrosion on the extinguisher.
- ✓ Fire extinguishers are under pressure and must be maintained properly to prevent a failure.
